Property Inspection Report

Inspection Report by: Kevin C. Fuqua TREC / TRCC Lic# 8273
K & S Inspections 310 Rocky Ranch Rd. Canyon Lake, Texas 78133

PROPERTY INSPECTION REPORT

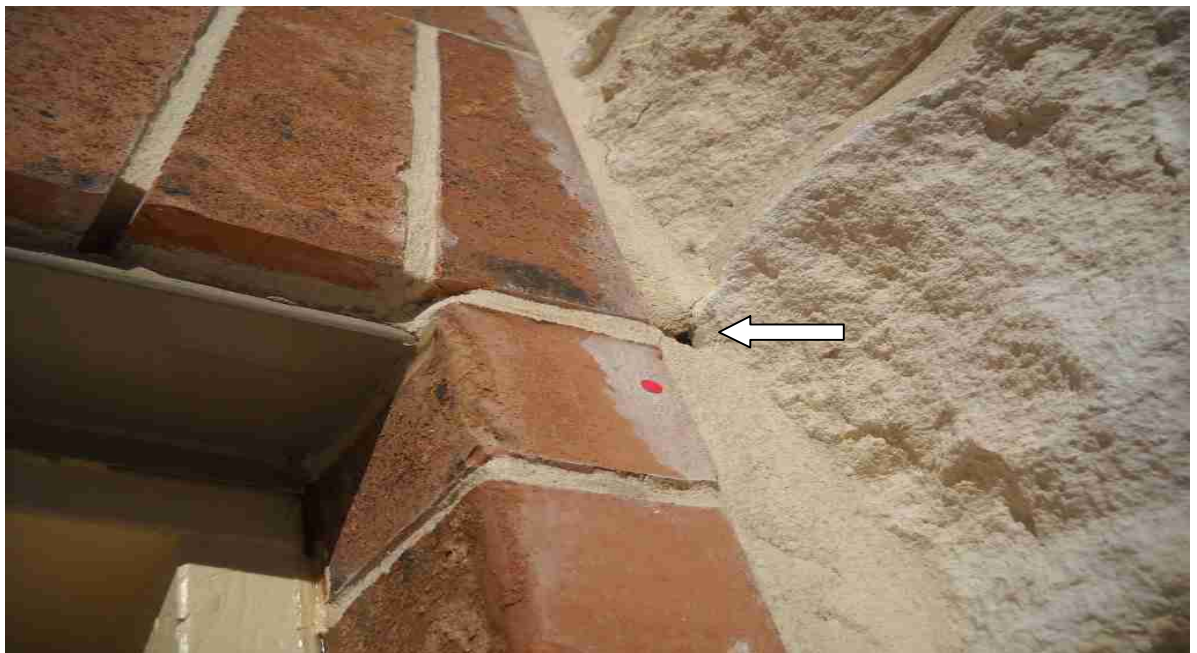
- A mortar improvement is recommended for the exterior, at the right upper corner of the garage door.

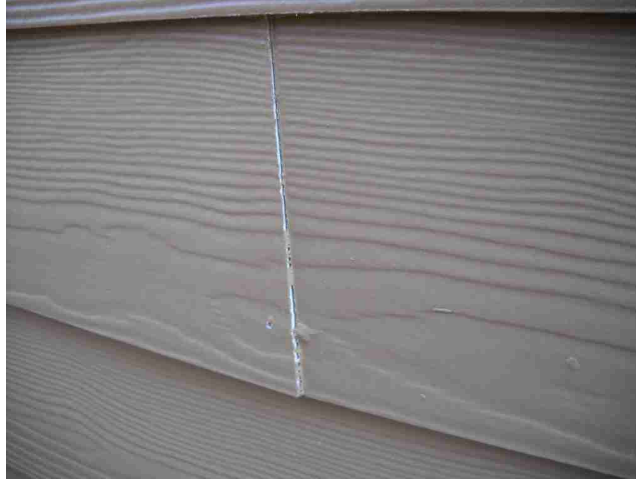
- The Hardi-siding is loose in areas and has gaps in the seams. It should be re-fitted and sealed.

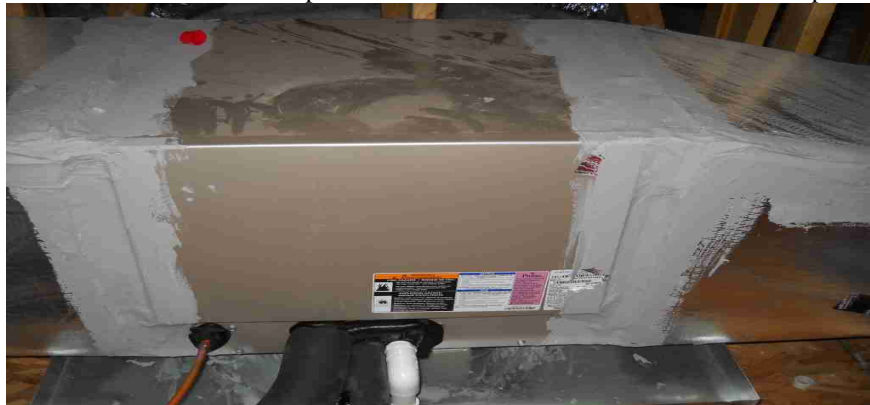
- All components of the Cooling Equipment were found to be in satisfactory condition at the time of the inspection.
- The Air Conditioning inside coil Pentium was tapped shut by the installer and/or service technician. Installers will tape the system shut to prevent air leaks and/or whistles, because the covers do not seal air tight anymore. The systems interior could not be checked due to that Inspectors are only required to open accessible openings. Inspectors are trained never to cut this tape. The inside coil is not covered under this inspection.

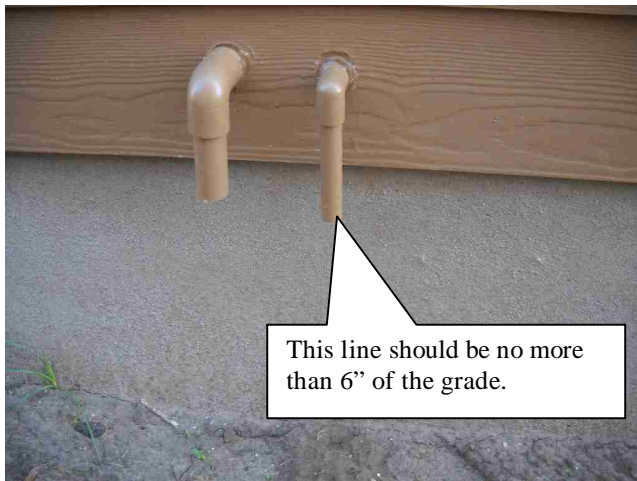
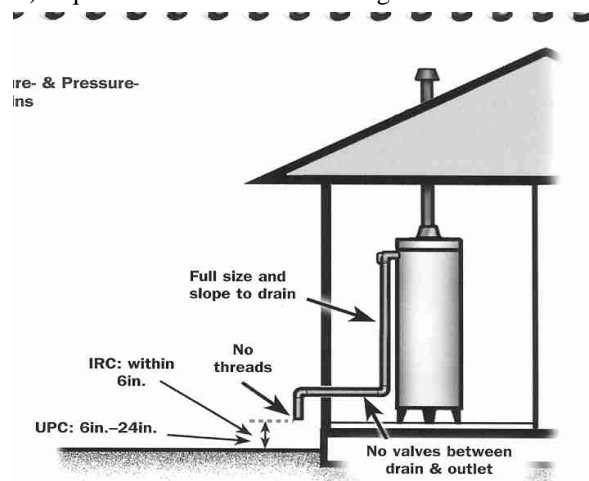
- The TPV extension should terminate within 6" of the ground. The UPC (United Plumbing Code) allows up to 24" although the IRC (International Resident Code) requires no more than 6" from grade.
